Brand new factory destroyed

Fire hazard underestimated at design stage

Rapid fire spread in a steelwork factory due to extensive use of combustible material.

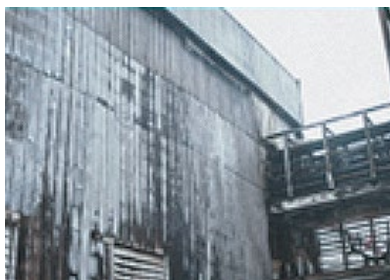
Gases released from the electrolysis process are drawn up into extraction hoods over of the electrolysis tanks. These fumes are taken via a single duct to the fume scrubber, which consists of two scrubbing towers, before being exhausted to atmosphere. **In order to avoid corrosion all equipment is made of polyethylene, an extremely combustible plastic.**

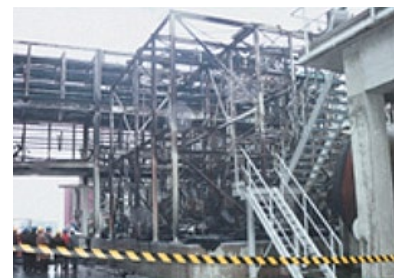
Fire originated in an electrical cabinet mounted on one of the polyethylene constructed scrubber tower. By the time the fire brigade reached the site, the fire spread along the pipe bridge to the main electrolysis building, with flames of 20 m high coming from the fume scrubber. When the fire brigade connects up to the hydrants, they notice that water pressure was very low and had to take water from the canal about 450 m away.

50% of site destroyed and production started with 15 months delay

Integrate loss prevention and fire protection methodology from the first design stage when a new factory or site extension is to be built
-

Use noncombustible ducts, equipped with fire dampers
-

Provide automatic fire protection systems
